Decommissioning Close Out Report Brynhild Pipelines

UNCOSTED VERSION

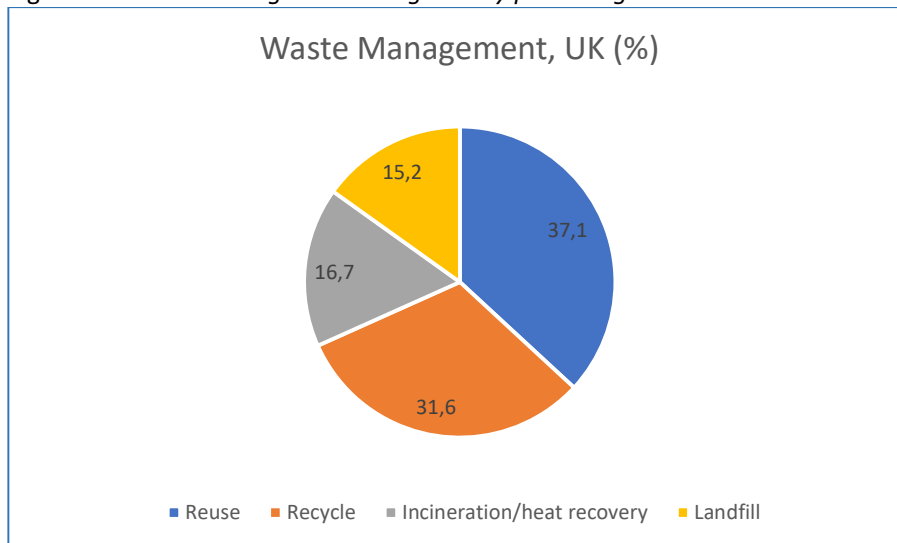
Figure 5.1 Waste management categories by percentage

Waste Management Plans (Doc.No. 14412-PEP-0001 and 21488-LUNAS-S-TA-00004) were applied to ensure compliance with the Waste Framework Directive. Waste returned to shore during the decommissioning of the Brynhild pipelines is detailed in Table 6.1 and Figure 6.1.

The decommissioning project defined a recycling target of minimum 67% which was achieved by a good margin.

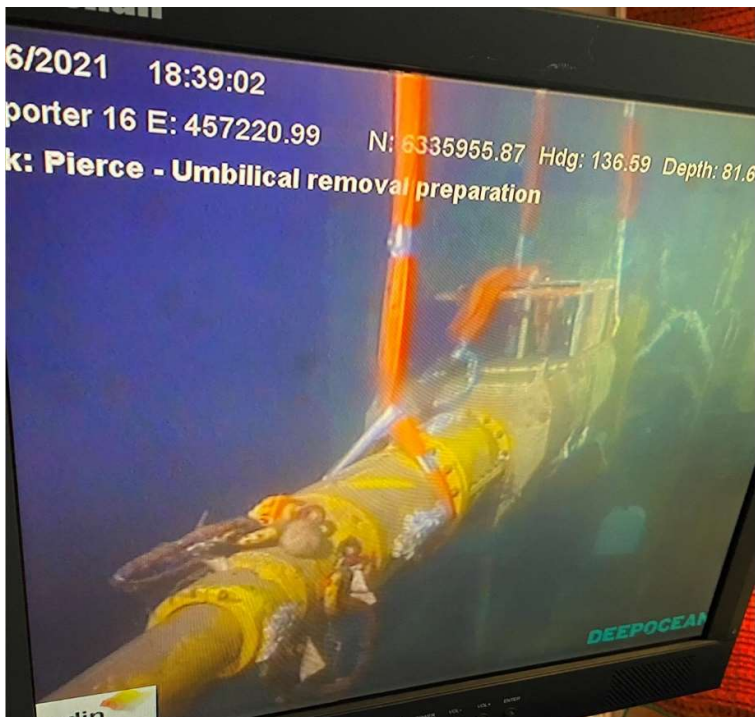
Photo #1 Umbilical flushing

The planned marine campaign comprised flushing of the umbilical (all chemical lines). Flushing of the chemical/hydraulic lines commenced 06.06.2021. Clogging significantly restricted the flushing flowrate. Despite of several attempts the flushing campaign was interrupted. Both BEIS and Norwegian authorities were informed during this incident. The Chemical Permit (BEIS) was updated and approved 08.06.2021 reflecting discharges to sea and abandonment of chemicals in the umbilical. PWA has also been updated and approved to reflect the as-left status.

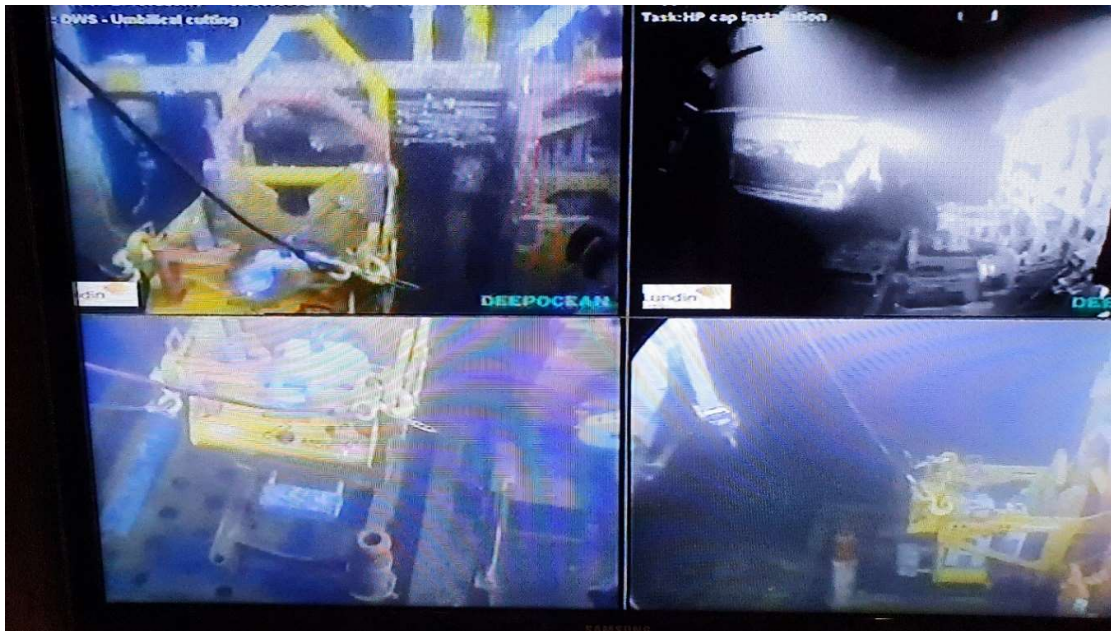
Photo #2 Umbilical disconnect from Pierce RBM (Riser Base Manifold)

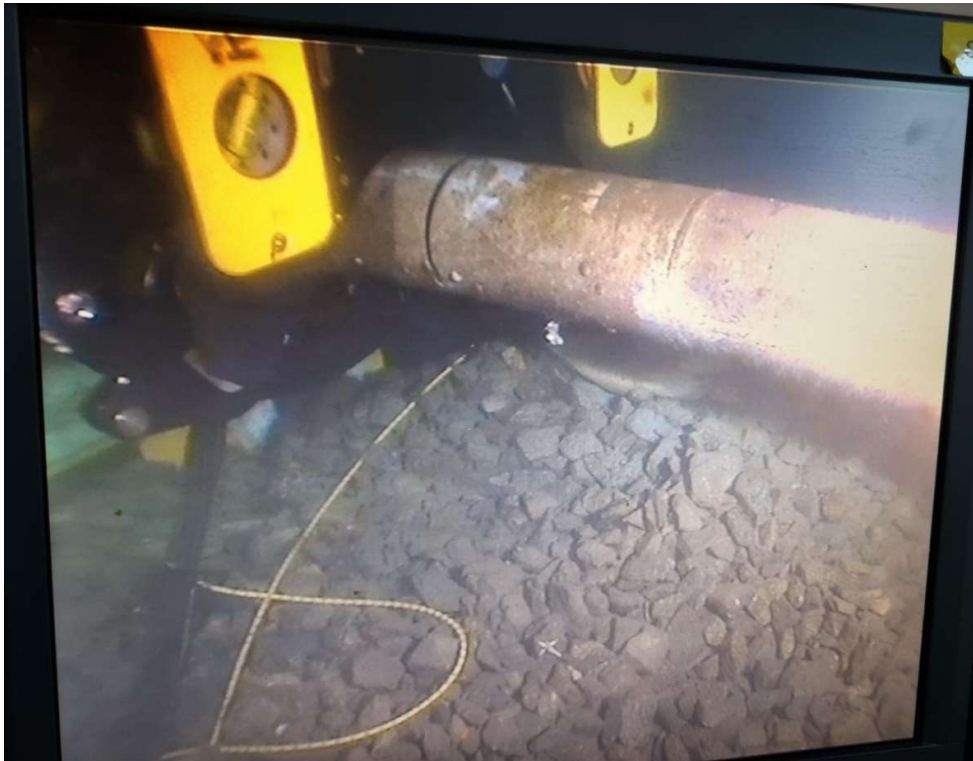
Photo #3 Installation of High Pressure Cap on Pierce RBM (Riser Base Manifold)

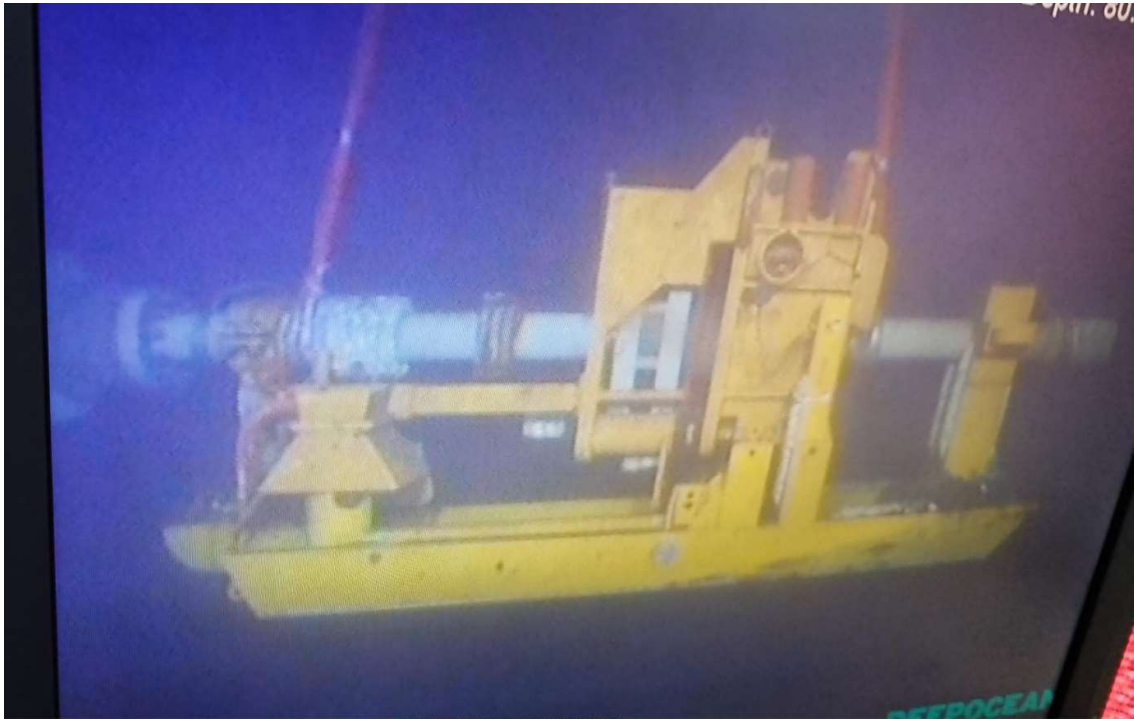
Photo #6 Rock removal from PLET GRP covers

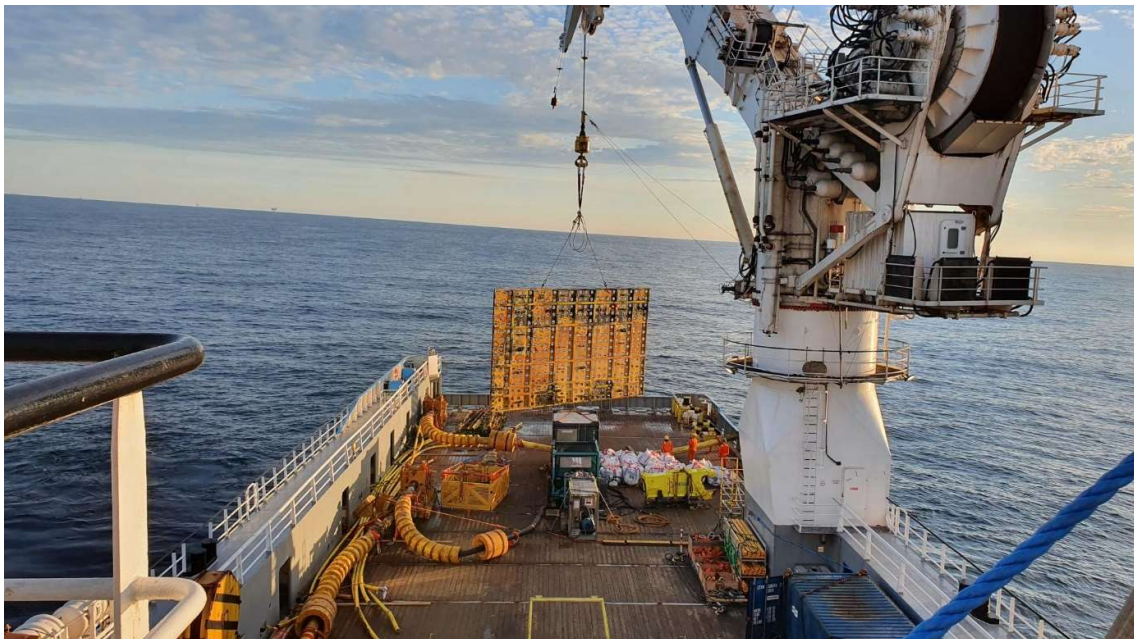
Photo #7 Recovery of PLET

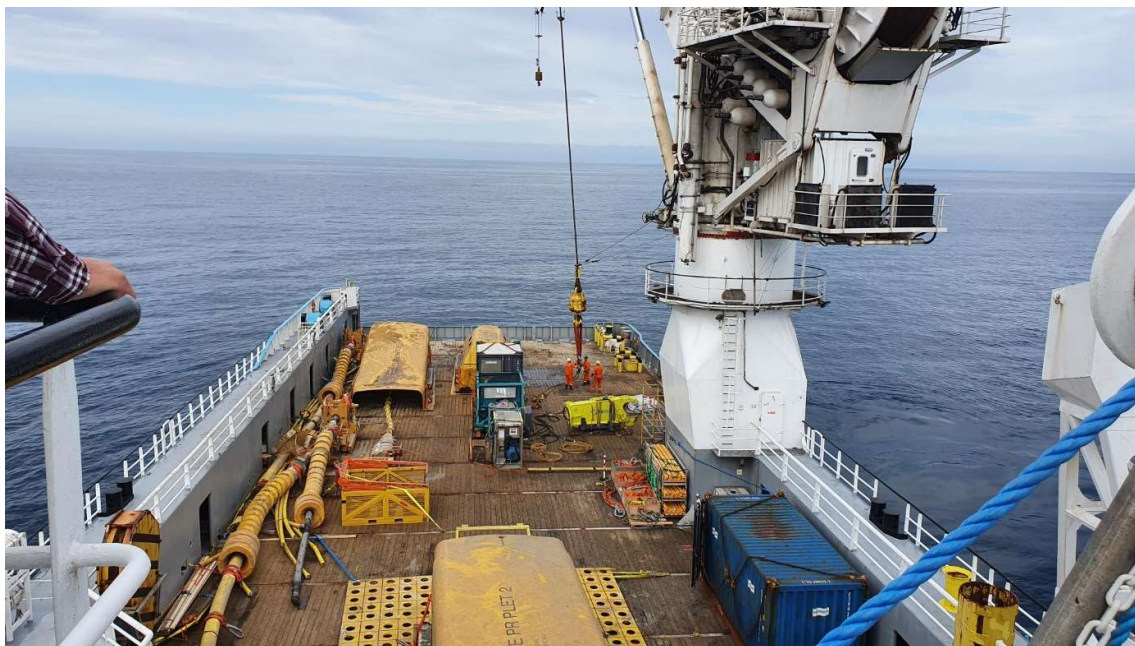
Photo #8 Recovery of PLET support frame

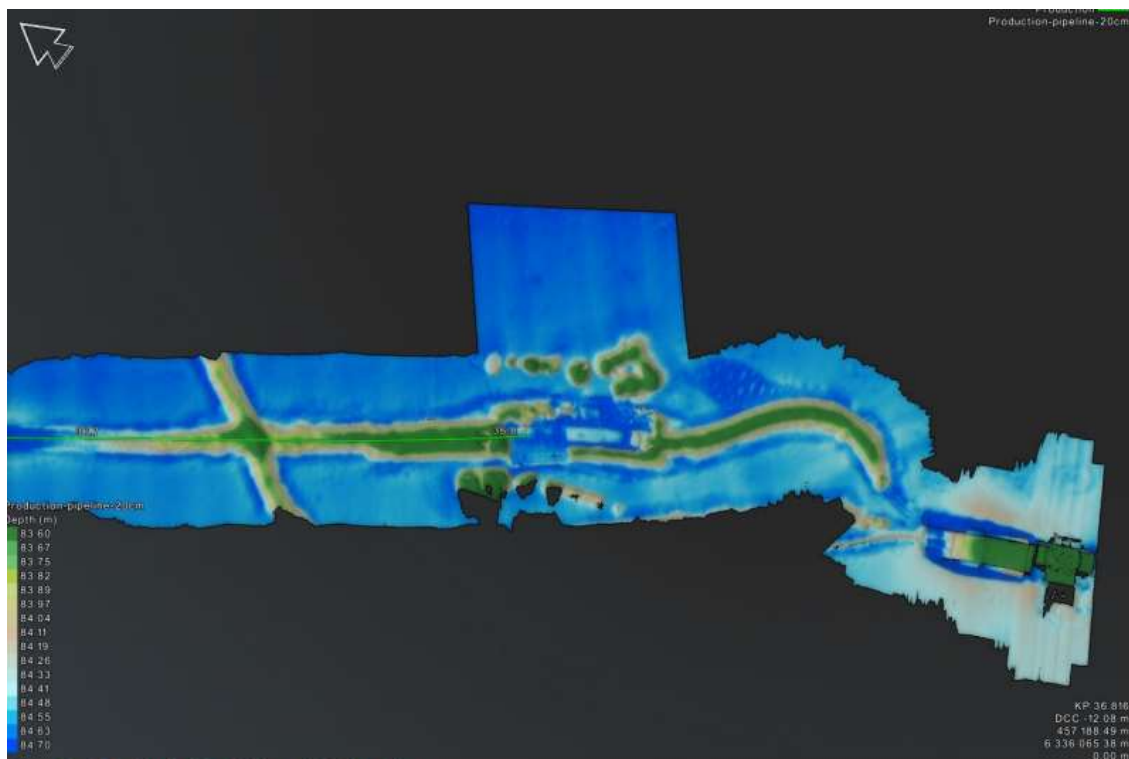
Photo #10 Multibeam survey of RBM surroundings

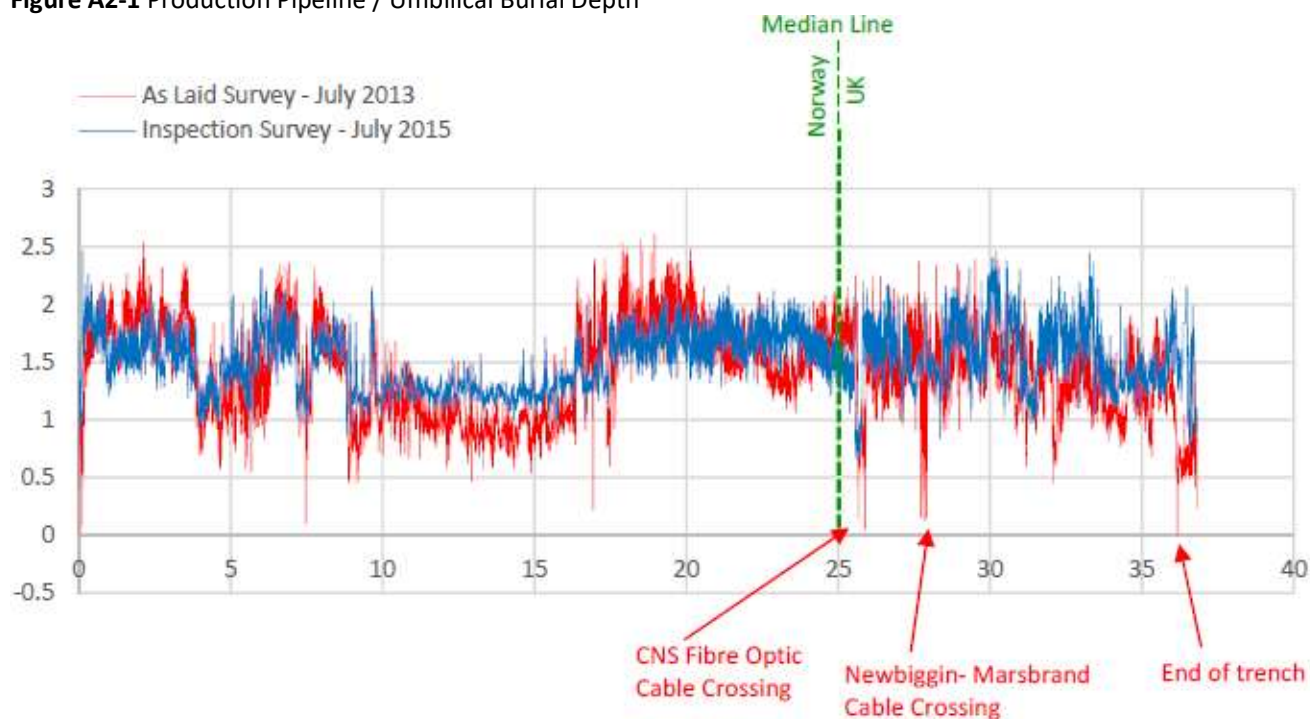
Figure A2-1 Production Pipeline / Umbilical Burial Depth

The graphs below show the measured depth of cover along the full length of each pipeline and umbilical, below seabed (0 being seabed level) from two separate surveys, a) an As-laid survey completed at the end of the pipelines installation in 2013 and b) an inspection survey carried out in July 2015.

The production pipeline and the umbilical share a common trench until they exit the trench near to Pierce (UK), at this point the pipeline and umbilical diverge but are fully rock covered on the surface and up to the cut points.

Graph vertical axis is in meters and horizontal axis is in kilometers.

2013 As Laid survey data excludes rock cover.

2015 Inspection Survey includes rock cover.

Pipelines and umbilical burial depths were recorded in 2013 and 2015. Results from the surveys in 2013 and 2015 are included in Appendix 2, showing a burial depth of more than 0.6 m along the entire route. No spanning, buckling or exposure has been observed in any of the later surveys in 2017 and 2021.
